03 / PREMATURE FAILURE IN BEARINGS

MOUNTING OF THE BEARING WITHOUT USING FERSA MOUNTING TOOLS

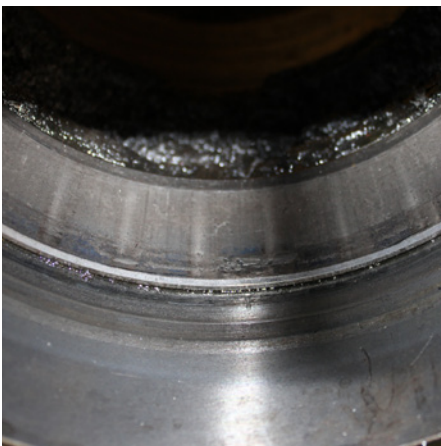
- We installed the bearings by pushing them directly on the bearing cone, damaging the whole piece.

- Marking the outer ring with the rollers when pushing from the cone. (F1)
- Premature noise.
- Detachment of material when rotating, due to the marks produced. (F2)
- If you do not solve the above problem, there will be a seizure of the bearings caused by the detachment of the material. (F3)

The Fersa fitters are specially designed to lock the seal and bearing without damaging any component.
Read the instructions for the correct use.
